RE: FINAL 2023 FAIRBANKS INTERNATIONAL AIRPORT FIRE TRAINING PIT  
INSTITUTIONAL CONTROL DOCUMENTATION, FAIRBANKS, ALASKA

Shannon & Wilson, Inc. (S&W) has prepared this letter report to document Fairbanks International Airport (FAI) former Fire Training Pit (FTP) institutional control (IC) compliance at the FAI in Fairbanks, Alaska. These services were conducted on behalf of the Alaska Department of Transportation & Public Facilities (DOT&PF), under Notice to Proceed P4-11-23 and in accordance with DOT&PF's Professional Services Agreement Number 25-19-1-013 *Per- and Polyfluoroalkyl Substance (PFAS) Related Environmental & Engineering Services*.

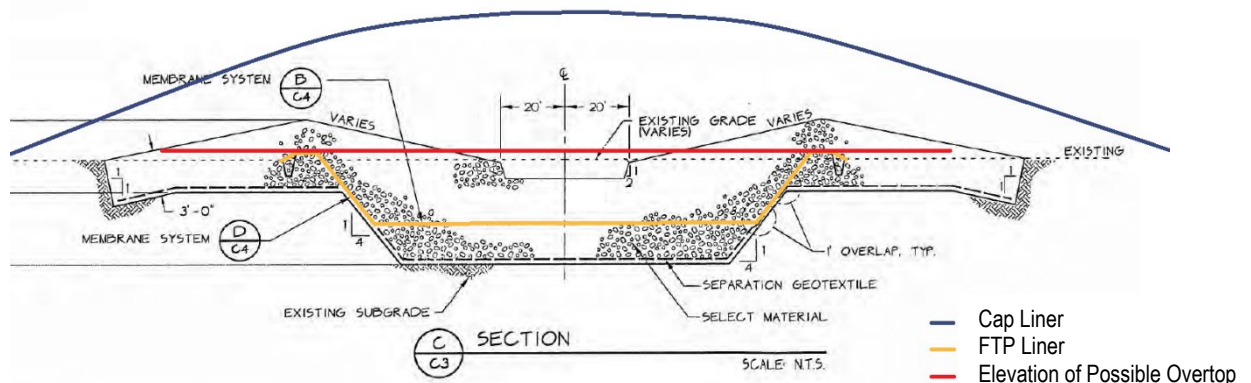
### Exhibit 1: FTP Schematic

In 2019, S&W, their contractors, and FAI Maintenance & Operations (M&O) personnel designed and began construction of the cap to be placed over the FTP. Cap construction was completed in June 2020. The cap consists of a geotextile placed directly on top of the FTP contents, followed by gravel fill, a 40-mil fortified polyolefin alloy geomembrane bound by geotextile, a layer of silty soil, topsoil, and hydroseed/vegetation. Exhibit 1, below, presents a generalized cross-section of the FTP, showing the installed cap liner (blue line) with respect to the original existing FTP liner (orange line).

Note: Schematic is exaggerated vertically, not to scale.

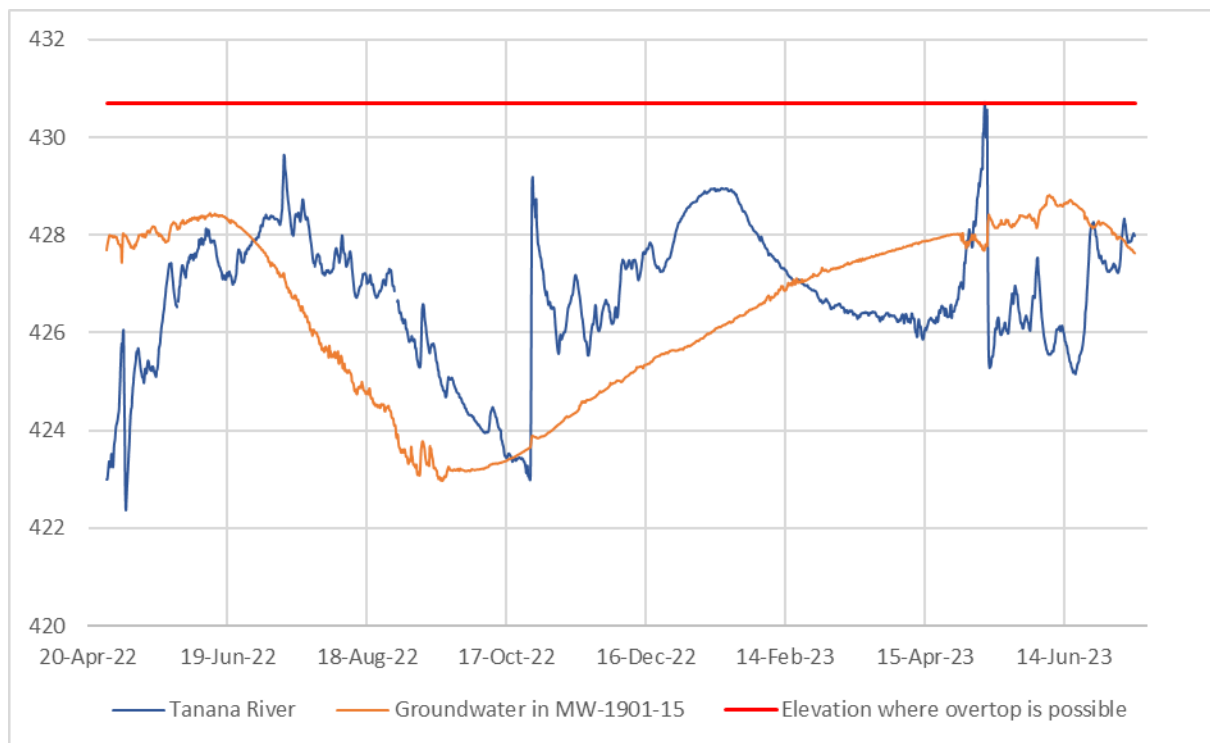
**Exhibit 2: 2022-2023 Elevation Comparison in Feet Above Sea Level**

Groundwater and Tanana River elevation data collected during the reporting period is presented with historical measurements in Exhibit 2 below.

No episodes of flooding conditions occurred during the reporting period. Per the Addendum this IC should occur for three years. The three-year period has passed and this IC has been satisfied and can cease.

- Continue controlling access to the former FTP for the lifetime of the cap, or until DEC determines the IC is no longer warranted.
- Cease groundwater and surface water elevation data collection.
- Continue to conduct monthly monitoring system inspections for the lifetime of the cap, or until DEC determines the IC is no longer warranted.
- Continue to conduct quarterly cap assessments for the lifetime of the cap or until DEC determines the IC is no longer warranted.
- Sample the former FTP upgradient and downgradient wells and the Don Bennett Range wells biennially for PFAS in the summer of even-numbered years (i.e., 2024, 2026, etc.).

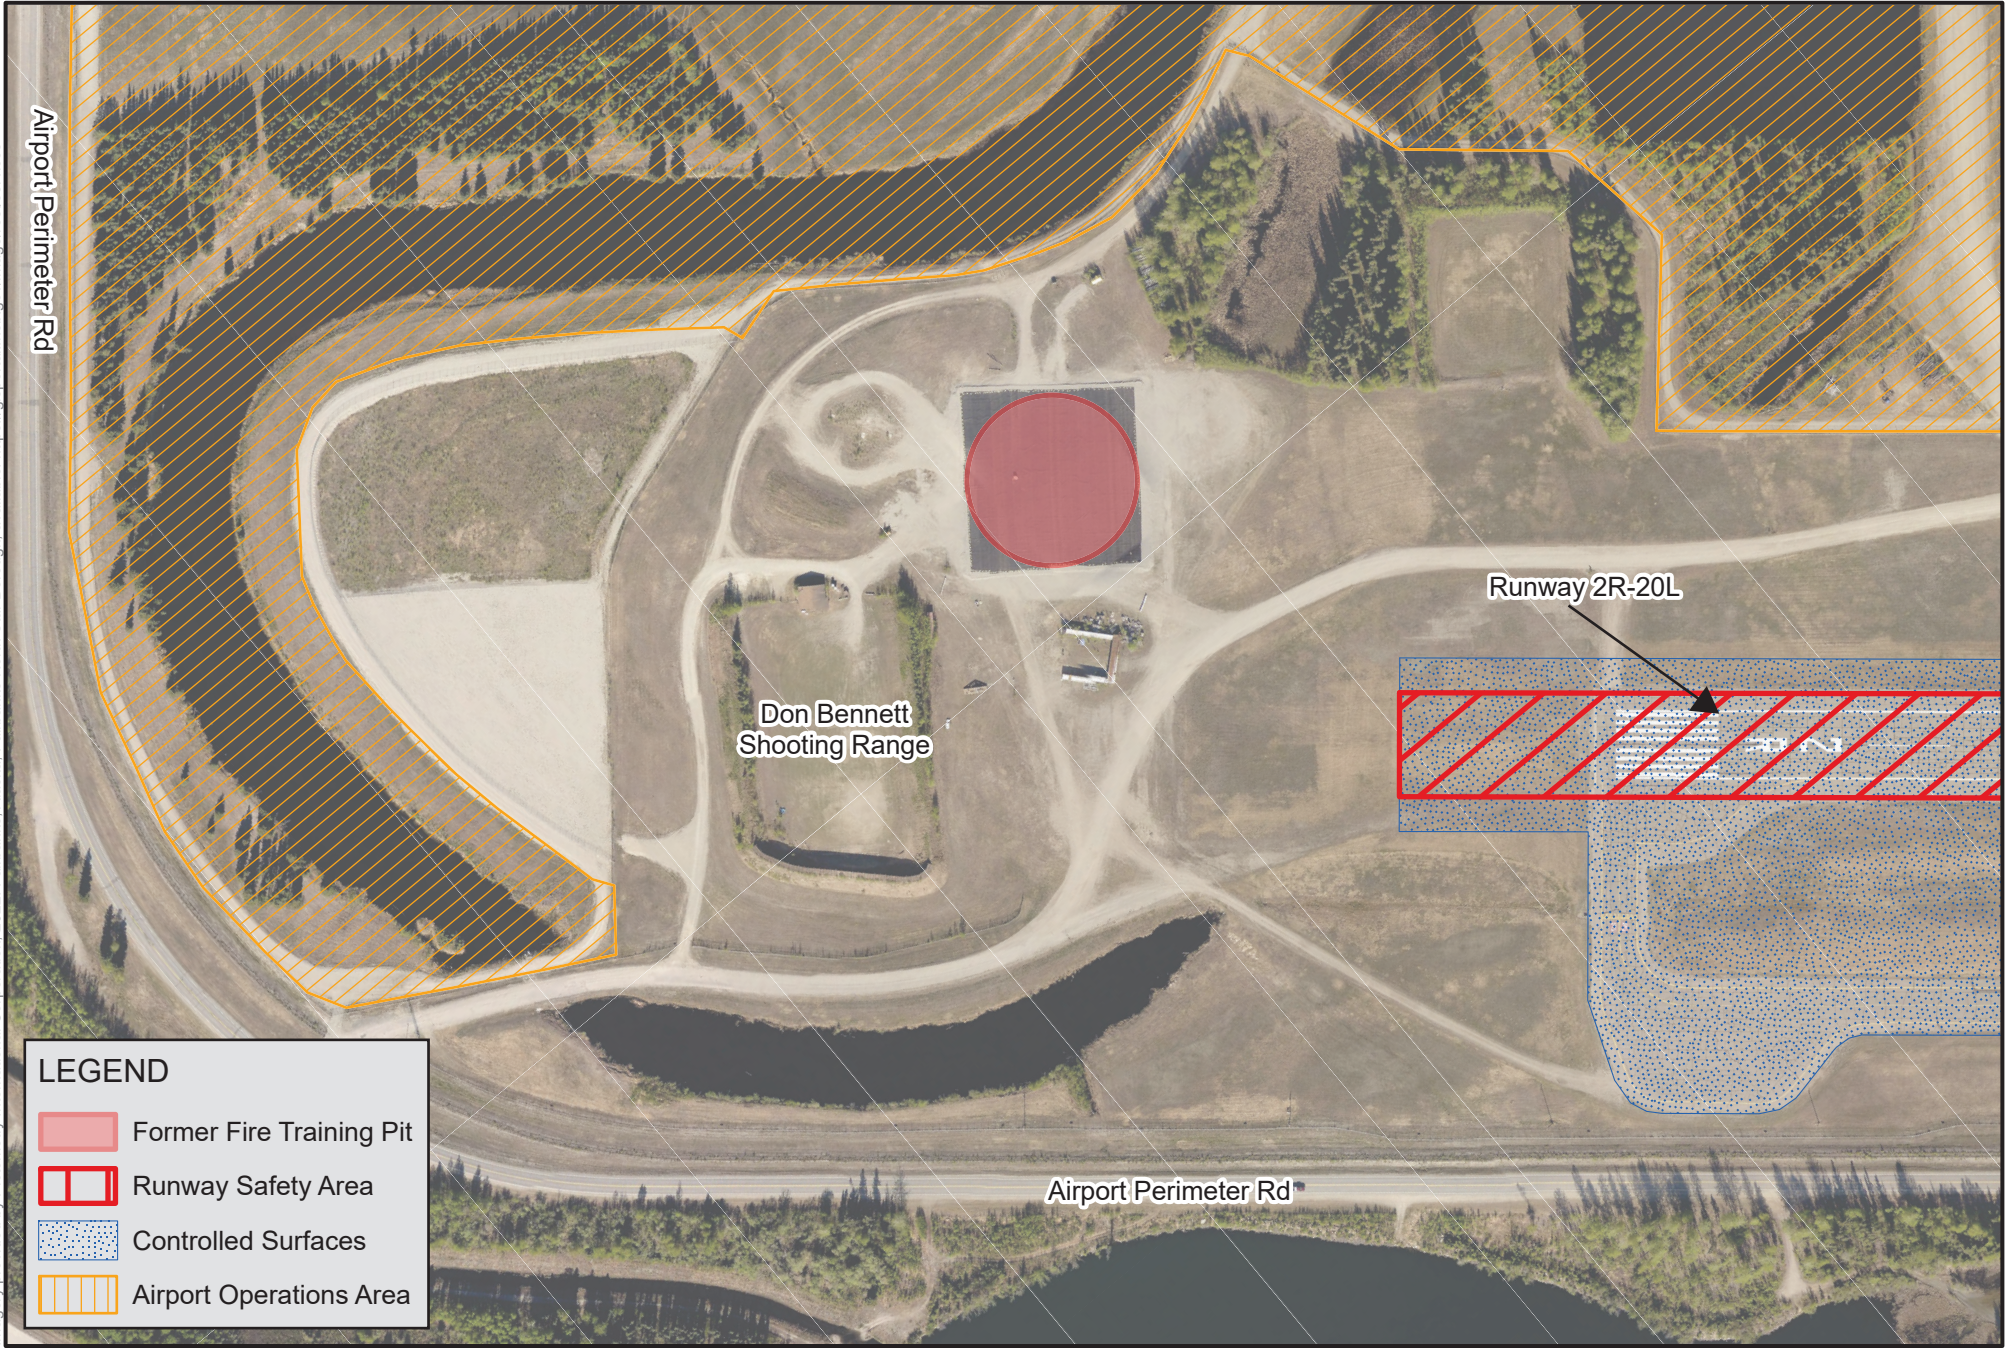
March 2024  
**VICINITY MAP**  
Figure 1

The former FTP is located south-southeast of the primary FAI runway, 2L-20R and south-southwest of runway 2R-20L (Figure 1). The geographic coordinates of the former FTP are latitude 64.7992, longitude -147.8808. The FAI former FTP was constructed in 1992 and 1993 as a 205-foot diameter basin built on a primary 80-mil high density polyethylene liner, containing well-drained fill material, and surrounded by shallow soil berms. The FAI Aircraft Rescue and Firefighting (ARFF) program used PFAS containing aqueous film forming foam (AFFF) at and adjacent to the former FTP from 1993 to 2017 for fire training and testing activities. The former FTP is an active, Alaska Department of Environmental Conservation (DEC) listed contaminated site due to PFAS and historic fuel contamination (File Number 100.38.070, Hazard ID 1071).

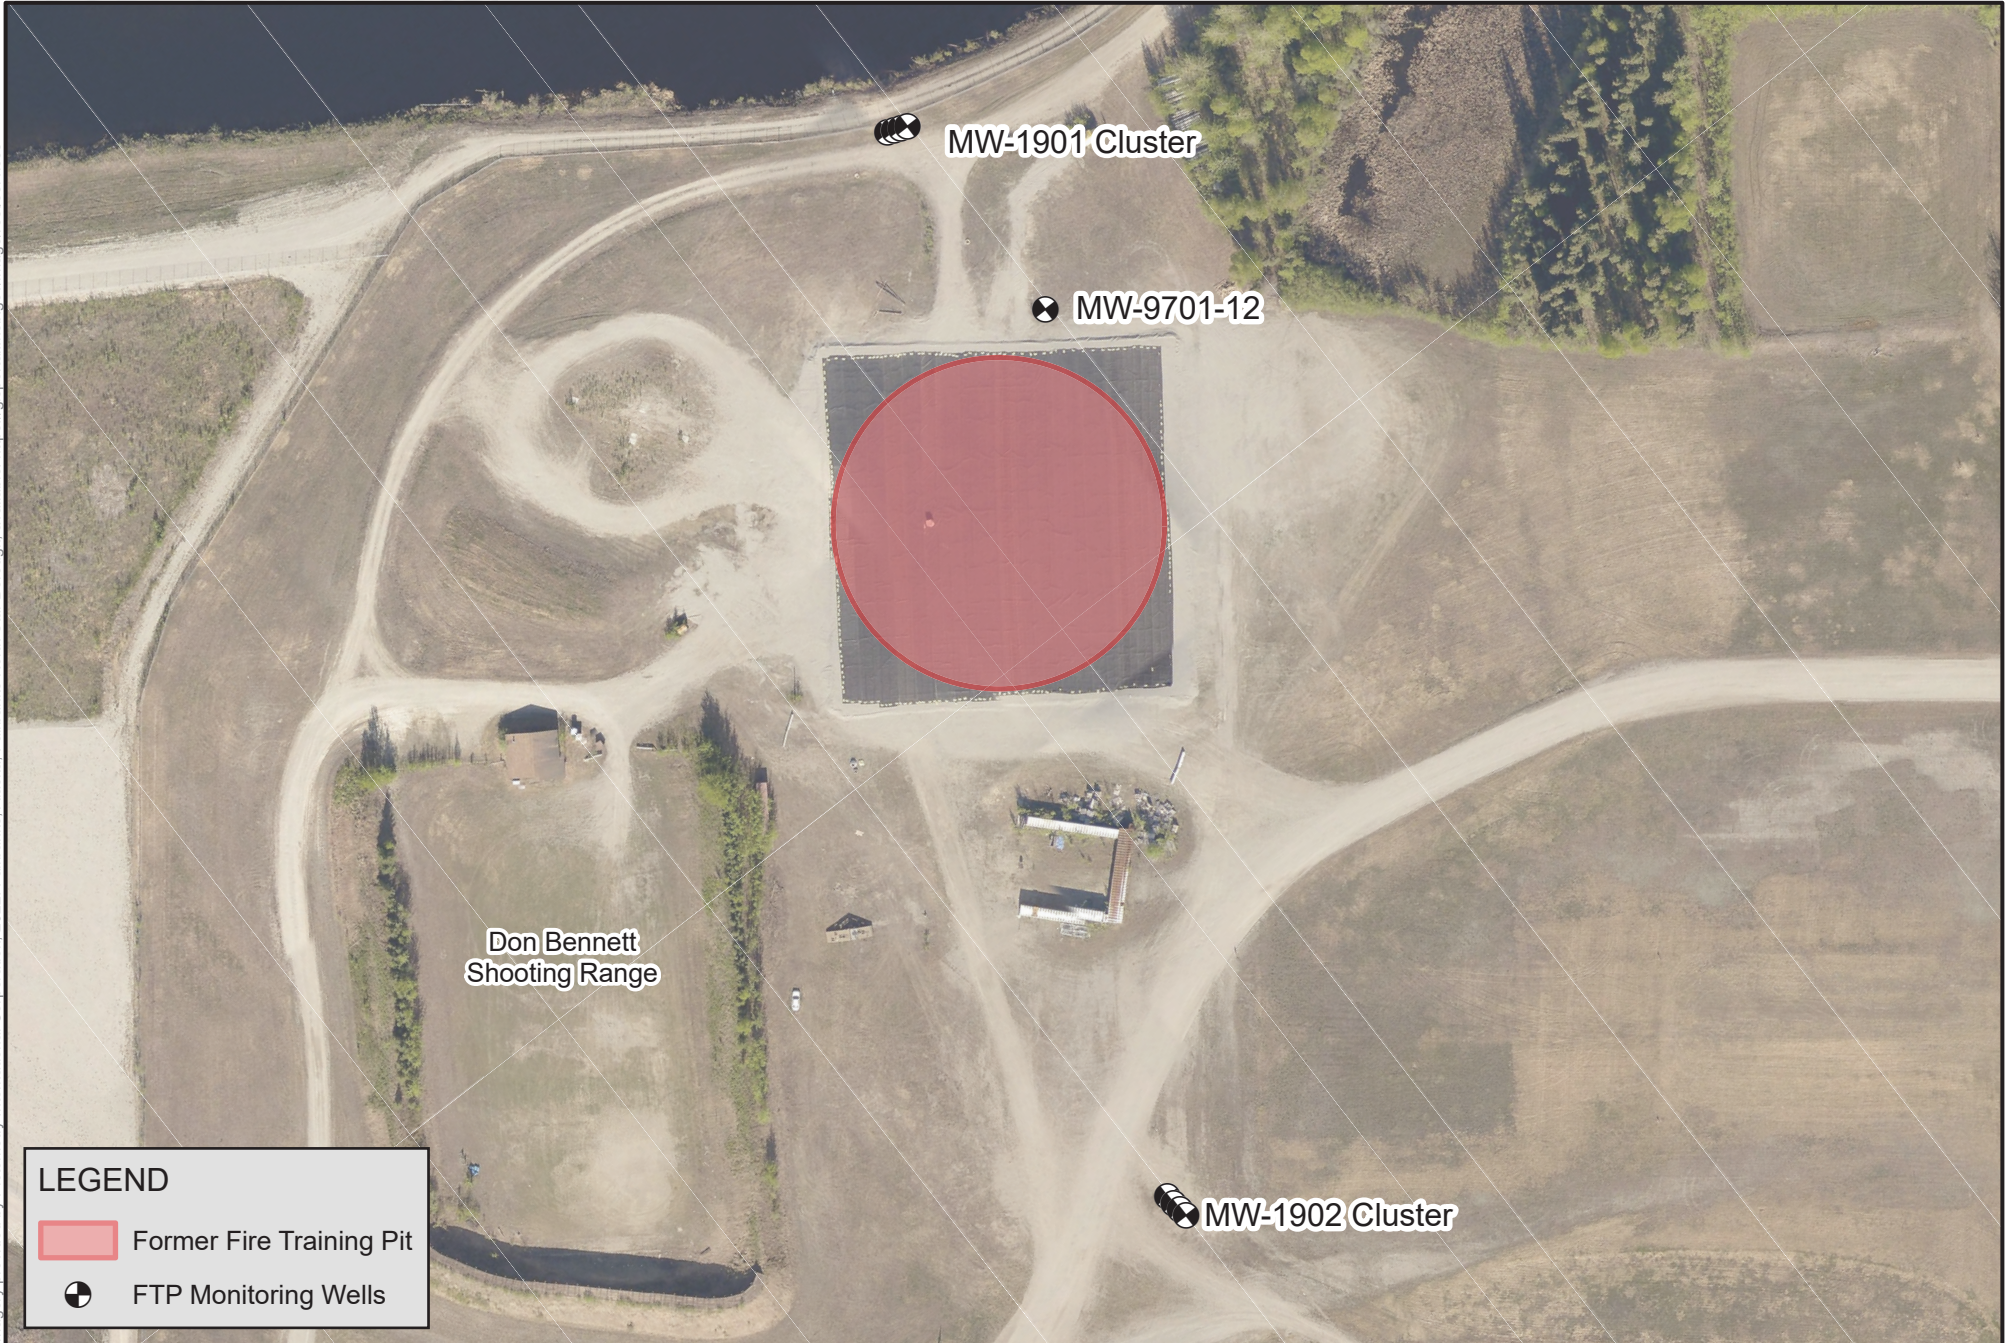
S&W began monitoring groundwater and surface-water levels near the capped FTP during our 2019 corrective action effort. On October 15, 2019, field staff installed a pressure transducer to log groundwater levels in monitoring well *MW-9701-12*, approximately 30 feet northwest of the edge of the FTP cap (Figure 2). Prior to installing the pressure transducer, field staff measured groundwater levels manually during the September and October 2019 monitoring-well sampling events. In February 2021, the automated pressure transducer was transferred to *MW-1901-15*. Groundwater elevation measurements are collected during monitoring well sampling events.

S&W sampled the monitoring wells upgradient (MW-1902-15) and downgradient (MW-1901-15) of the former FTP (Figure 2) quarterly for one calendar year. Sampling occurred in June and October 2020 and January and March 2021. Groundwater samples were submitted for analysis for DRO, VOCs, and per- and polyfluoroalkyl substances (PFAS) to monitor the integrity of the existing FTP liner. For the second calendar year, S&W sampled the monitoring wells upgradient and down gradient in October and January 2021 for PFAS, and April 2022 for PFAS, VOCs, and DRO. The sampling frequency was subsequently reduced to annual for PFAS only.

**Notes:**  
1. Monitoring well clusters MW-1901 and MW-1902 have well depths from 15 feet to 150 feet bgs.  
bgs = below ground surface

Monitoring well inspections are conducted on the two FTP monitoring well nests (MW-1901 and MW-1902) during monitoring well sampling events.

Monitoring well maintenance should continue to occur during monitoring well sampling events. Frost jacking was noted on MW-1902-15 during the July 2023 event. Currently, each monitoring well in nests MW-1901 and MW-1902 are fully functional.

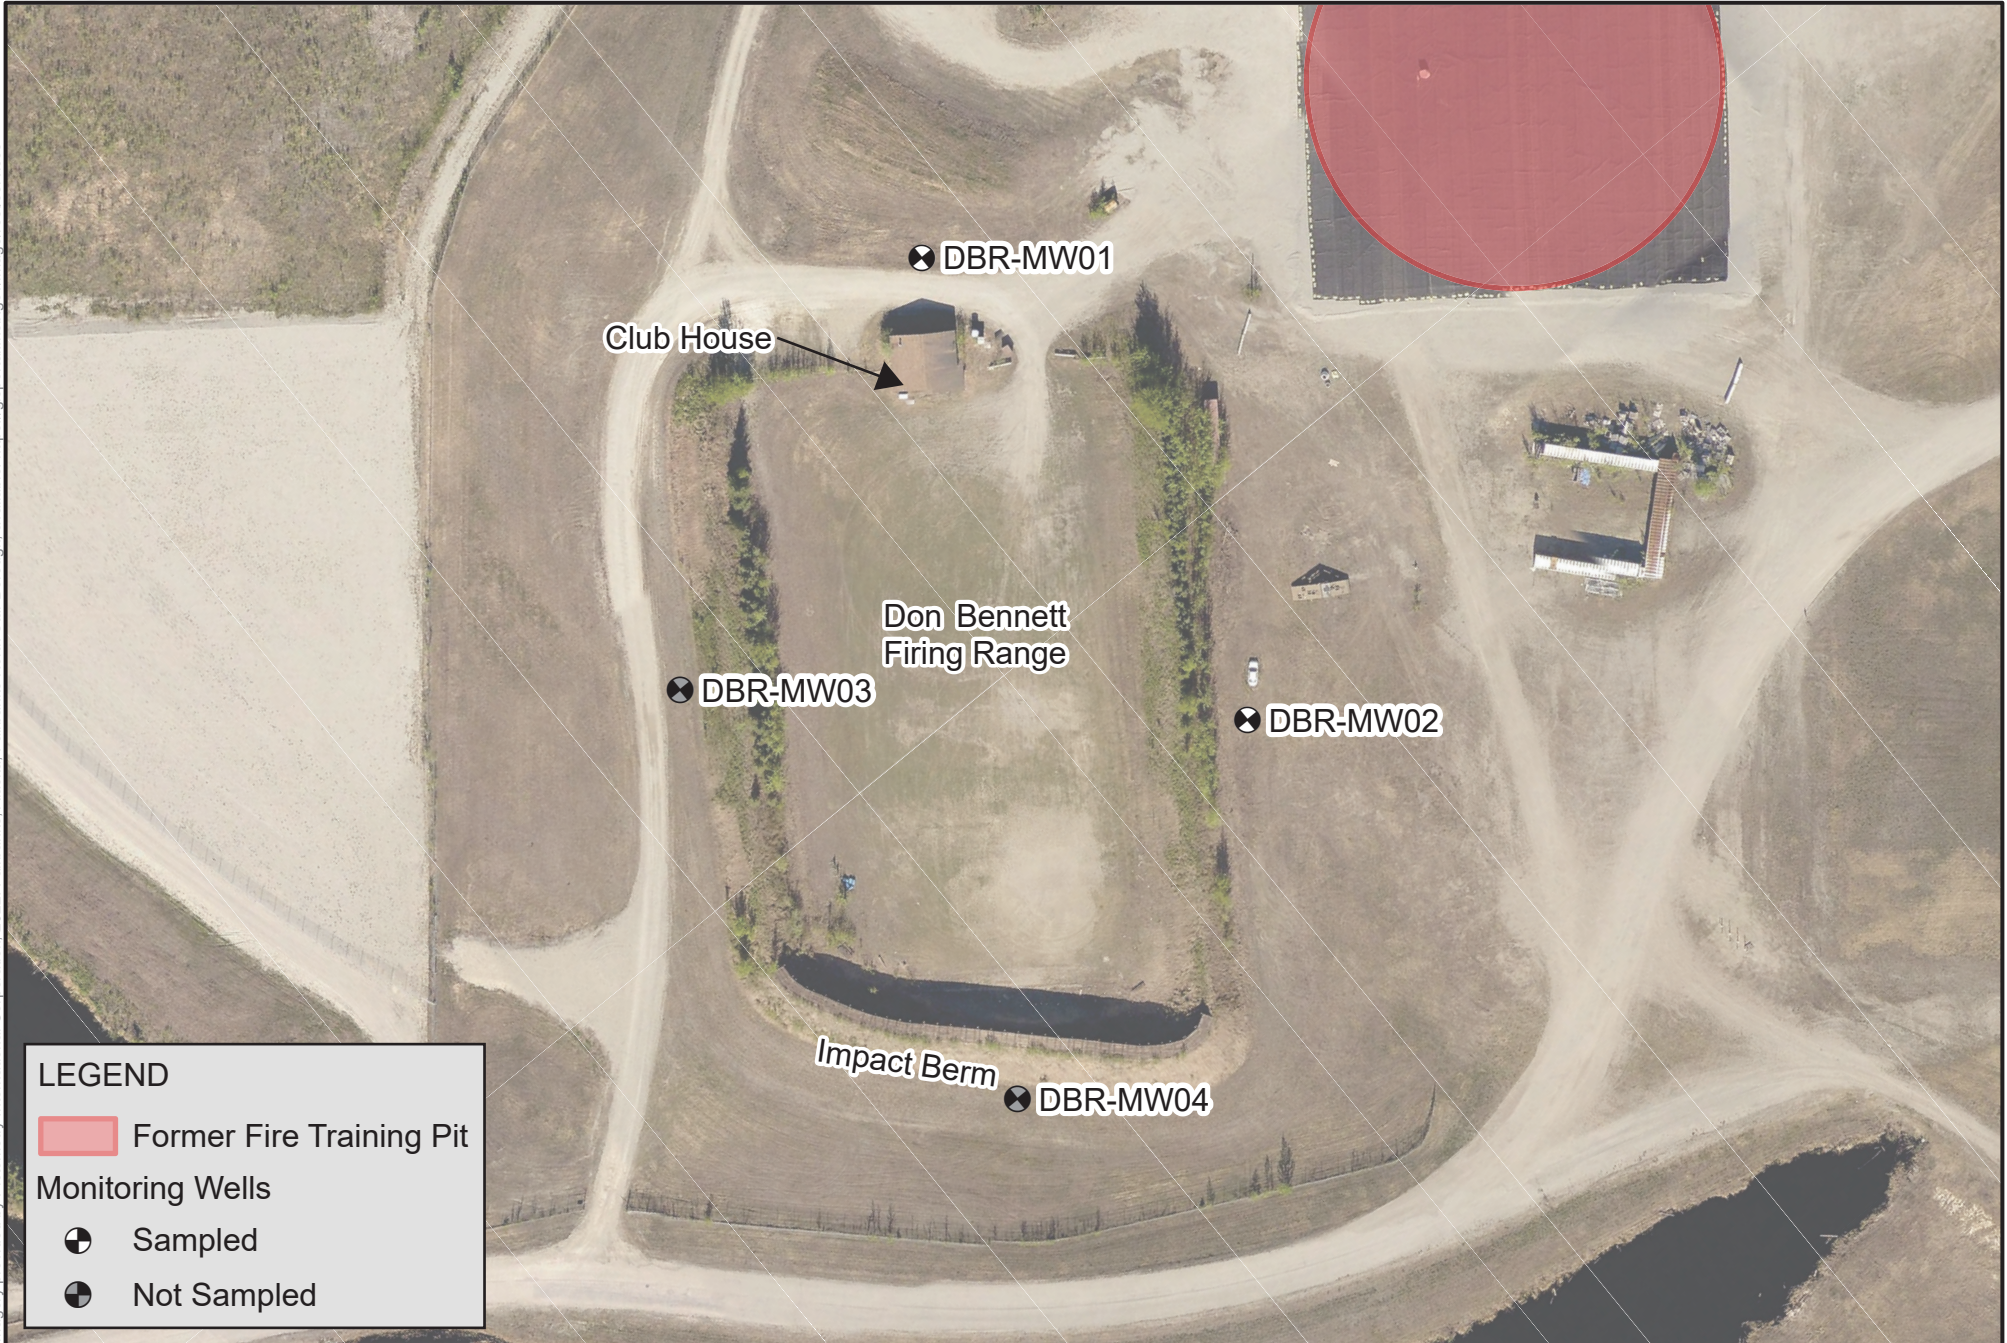
March 2024  
**DON BENNETT RANGE MONITORING  
 WELL LOCATIONS**  
 Figure 1

At the request of FAI, during July 2023, S&W field staff also collected groundwater samples from two monitoring wells located near the Don Bennett Range (DBR-MW01 and DBR-MW02, Figure 3) adjacent to the FTP. These wells were installed for monitoring a PFAS release at the Don Bennett Range. Concentrations of PFOS and PFOA did not exceed DEC groundwater CULs. An analytical results table for the Don Bennett Range wells is also attached (Table 2).

**Notes:**  
 1. Monitoring well locations are approximate.  
 2. Information from Brice Environmental 2022  
 Sample Locations and Results, Figure 4-1; January 2023

Per the Addendum, the former FTP upgradient and downgradient wells will be sampled for PFAS biennially in even-numbered years (i.e., 2024, 2026, etc.). FAI has also requested to include sampling of the Don Bennett Range wells DBR-MW01 and DBR-MW02 (Figure 3) during the monitoring events for the FTP monitoring well nests.
